Carrier	PQC
Vessel	PQC VESSEL
Voyage	001 002
Operation	Post-Discharge and Pre-Load
Port	Bremerhaven
Berth	NH AK1

Audit Results

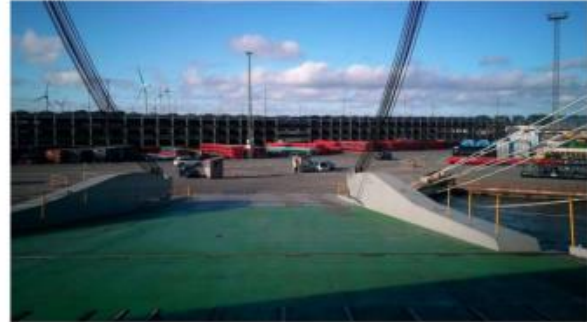
A-1 General condition Terminal.

Operations area next to the ramp was clean and without complaint.

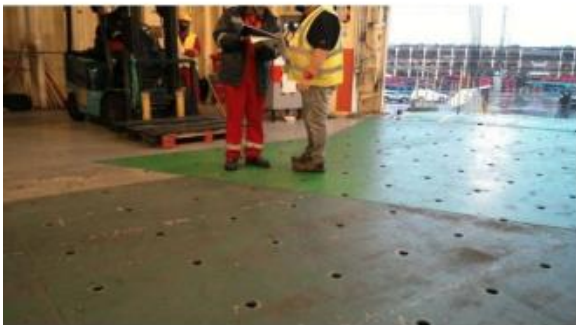
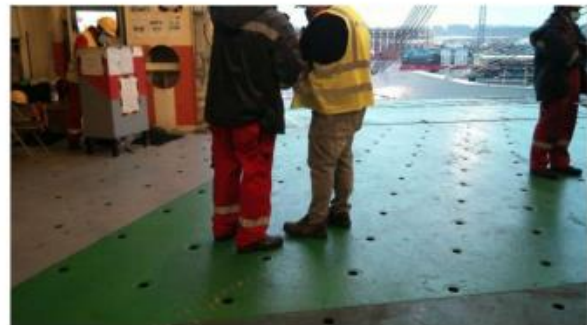
A-2 Communication/Cooperation of all involved parties during operation.

Pre meeting held at security station on main deck. All relevant issues were discussed.

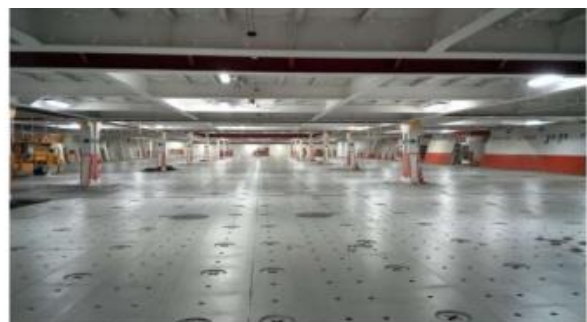
A-3 Decks clean and be in order, dry, well lit and ventilated.

All decks were cleaned up, well lit and good ventilated. Nothing to complain.

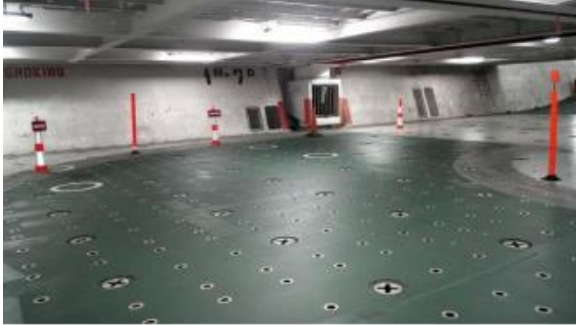
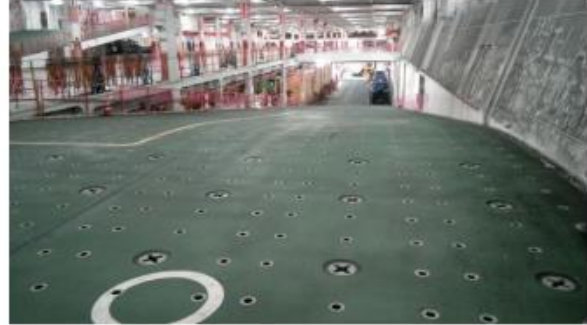
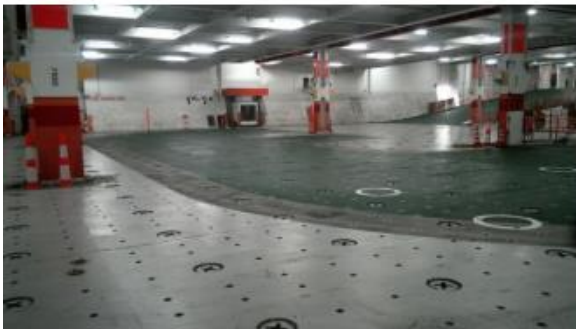
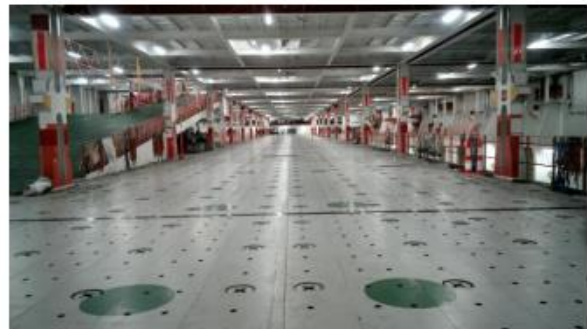
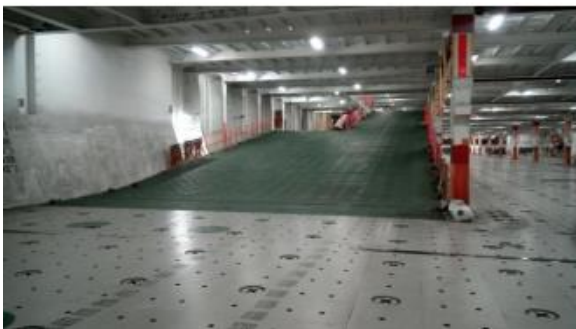
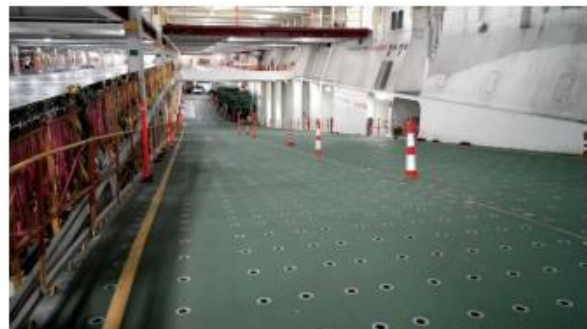
A-4 Driveways and Deck heights clearly marked and proved before commencement of operation.

Driveways were marked good and marking was constantly updated due to the progress of operation.

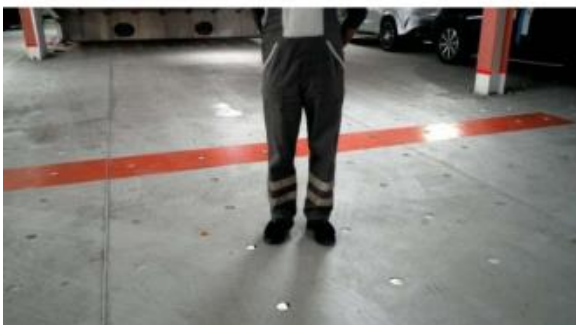
A-5 Dress code Drivers, Stevedores, Lasher and ILA-Crew: clean boilersuits, jackets etc. without metal (no rings, watches ect.).

Drivers dress were clean and without metal applications.

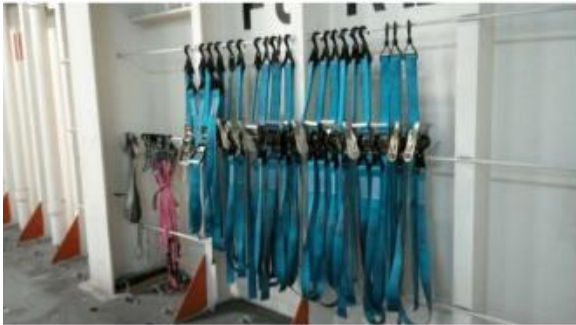
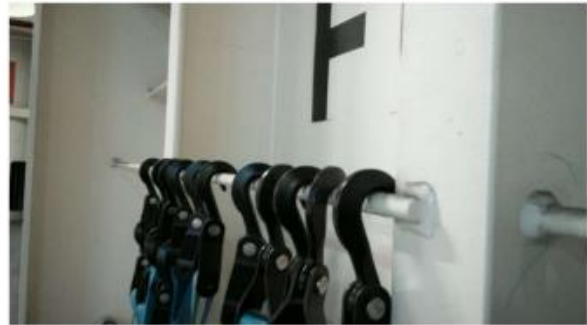
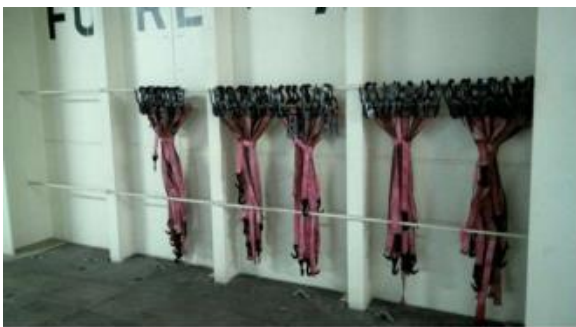
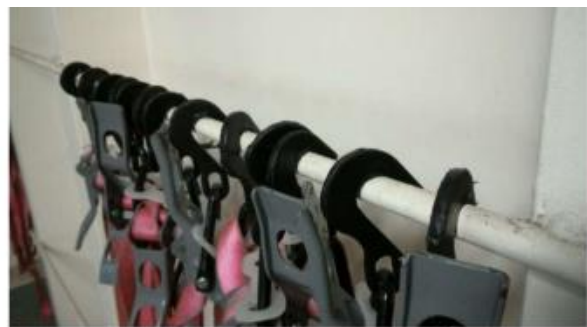
A-6 Lashing material stored in designated places and secured.

Lashing material stored in designated places and secured. Hooks and clasps in good condition.

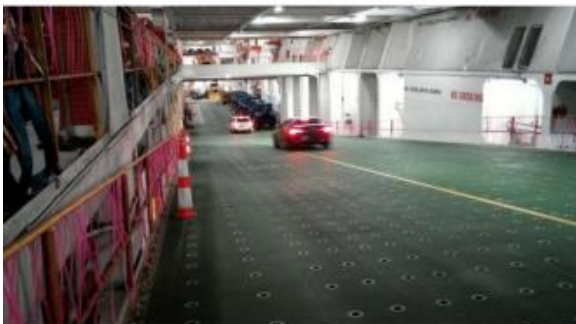
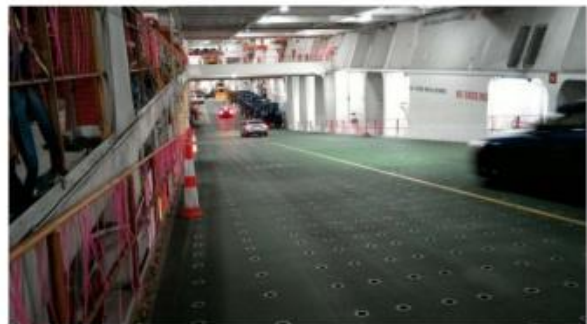
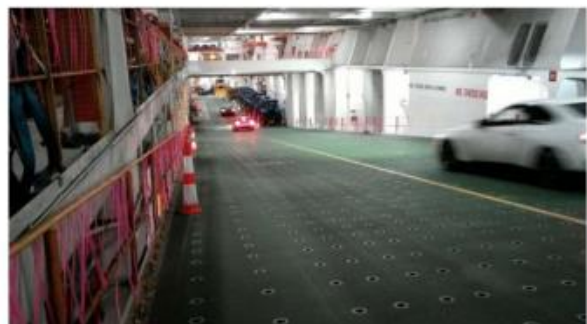
B-1 Safe speed, careful driving and 10m distance between two cars on driveways and ramps.

The drivers drive safely + carefully.

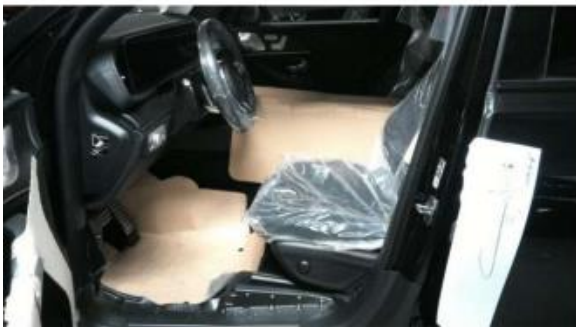
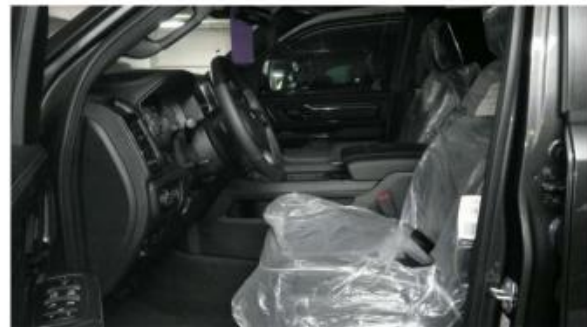
B-2 Vehicles stowed in accordance to the manufactures requirements (key, brake, seatposition, seatcover). Steering wheel in right position.

Meeting the manufactures requirements.

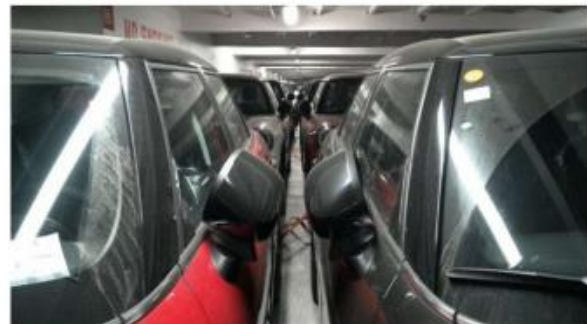
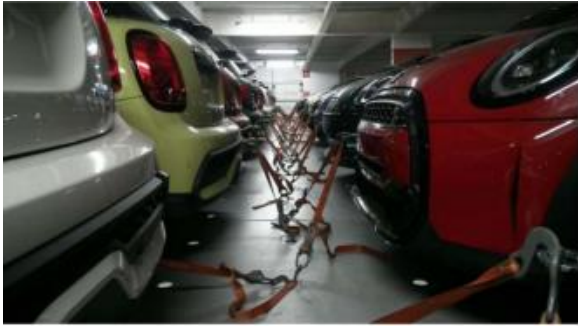
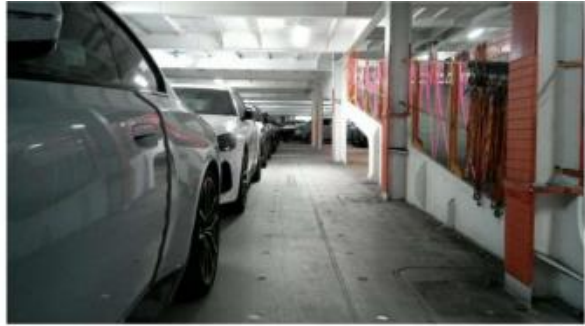
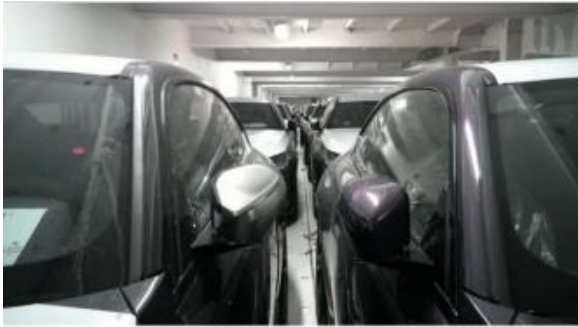
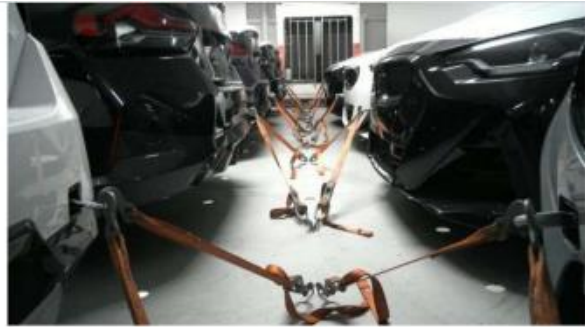
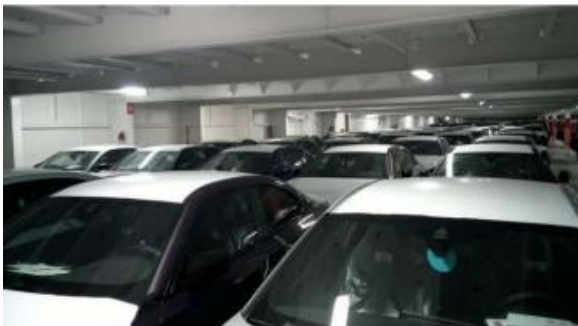
B-3 All vehicles parked correct distances with bumpers in line/sides/walkway/bulkheads/deck head and model by model. Minimum space to RoRo units ca. 1m.

The cars parked good in distance between bumpers and mirrors. Good distance also to boardwall and pillars. Loaded model by model.

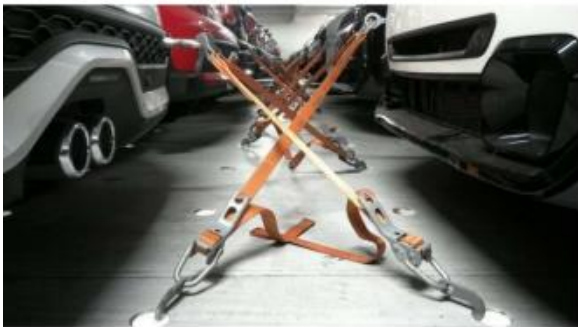
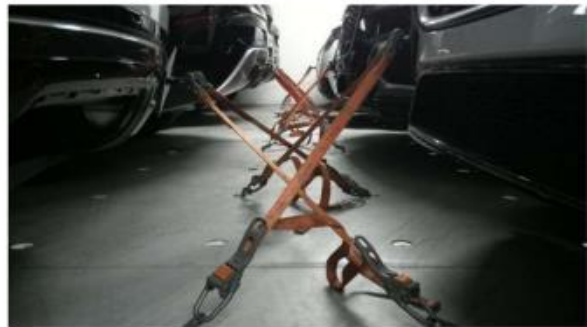
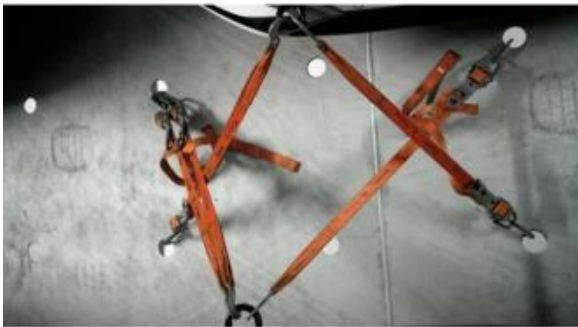
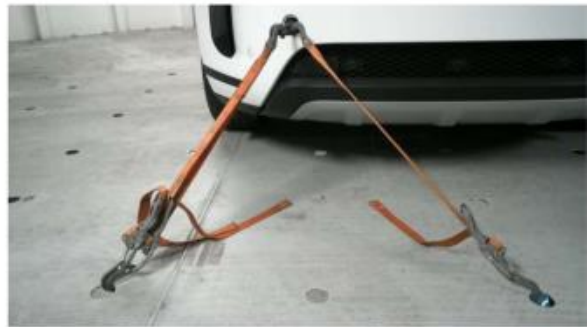
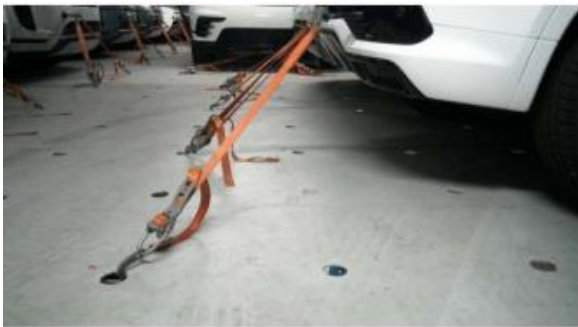
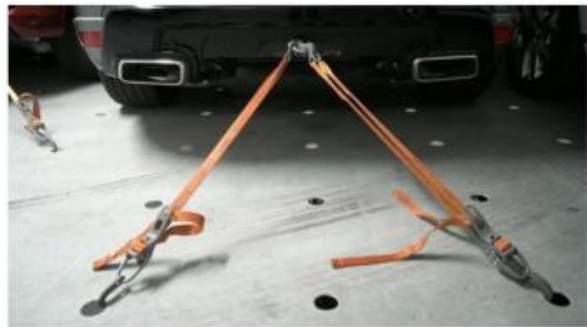
B-6 Lashing done to manufactures requirement (pressured/twisted/lashing angle/hook attachment). Usage of wedges. Rim lashing at MB code666.

Lashing done good in angle and lengths.

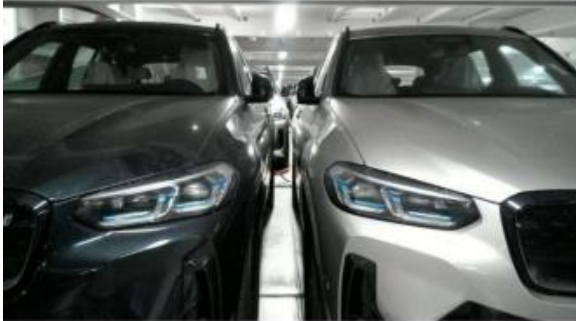
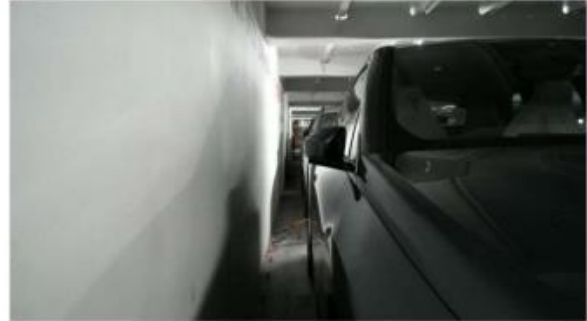
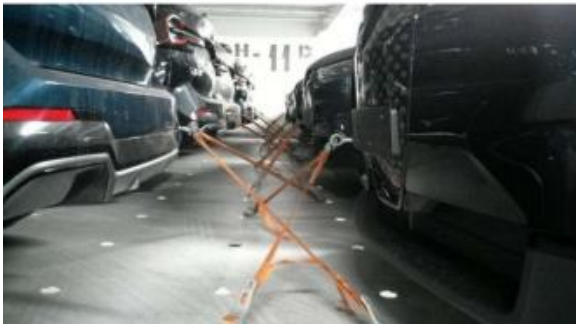
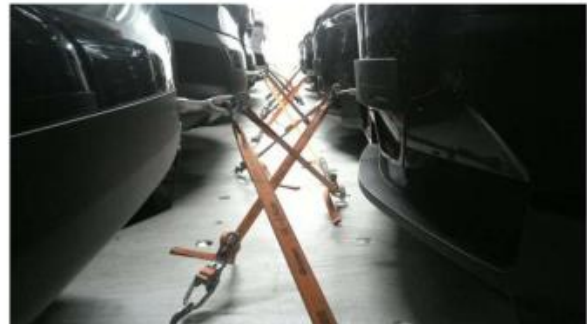
B-7 Stowage of electrical cars accordingly to K-Line requirements (10cm door/door and 30cm - with ibolt 50cm bumper/bumper) and corresponding stowage plan.

Found EV stowed in between regular stow.

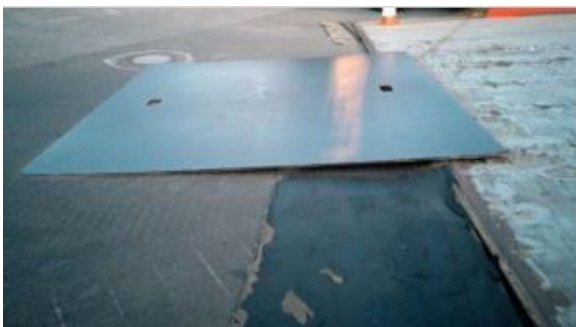
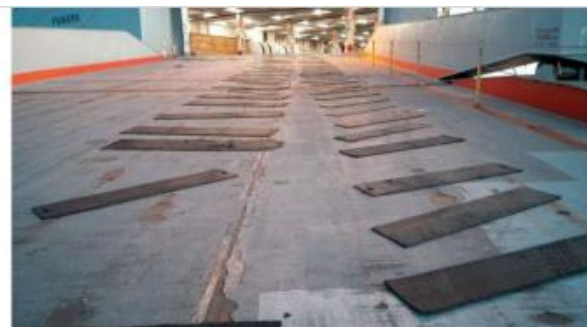
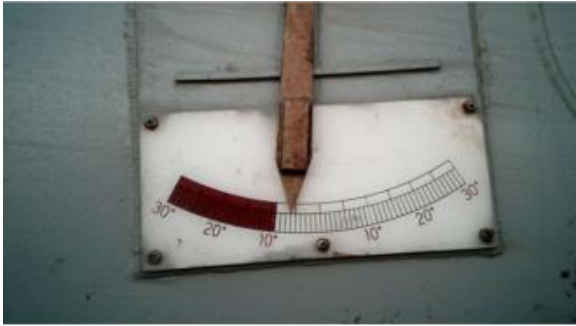
C-1 Proper ramp angle (8 degree) and protection measures at ramp for H&H cargo.

Ramp was well prepared with top ramp angle for loading and discharging, as also protection measurements. Steel plate was placed at stern ramp.

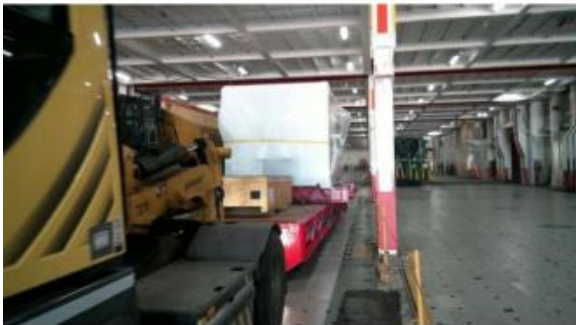
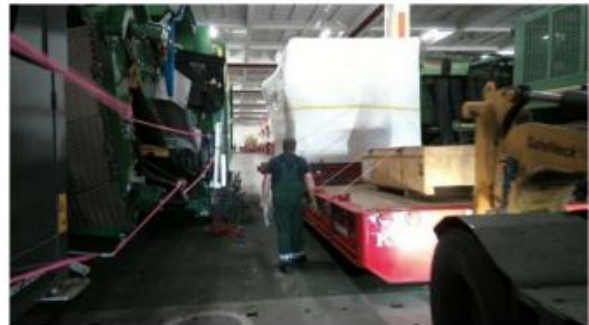
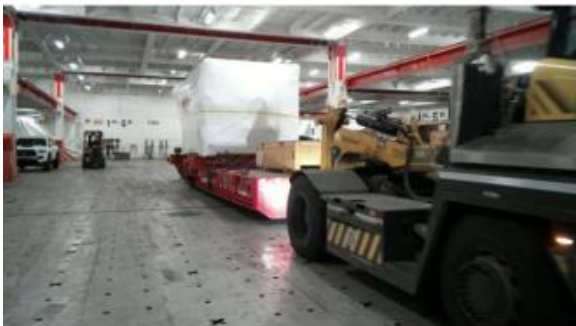
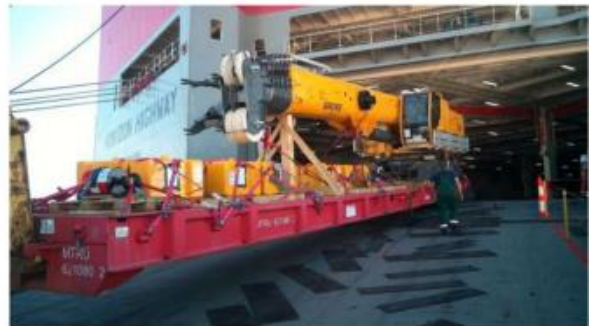
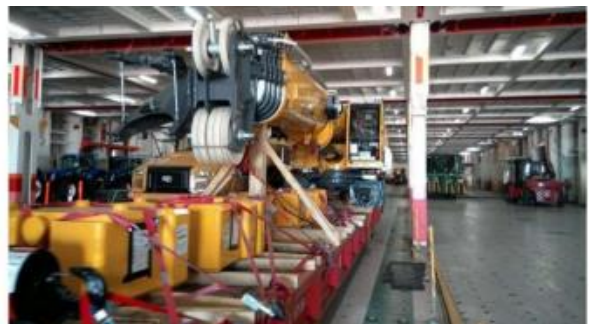
C-2 Safe handling H&H units during loading/discharging. Stevedore escort H&H onto ramp.

Good handling during loading, drive carefully on the ramps. Safety handling with tugmaster into final position. Driver acts attentive to stevedores handsigns.

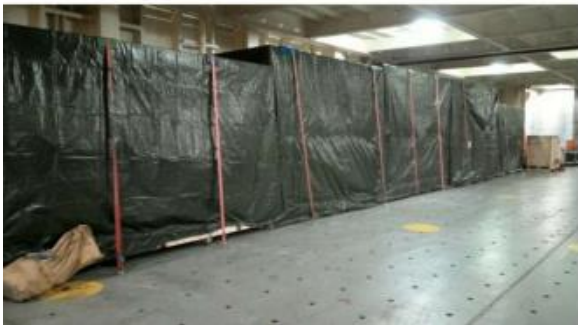
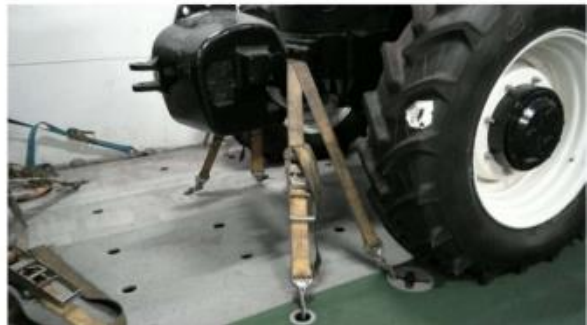
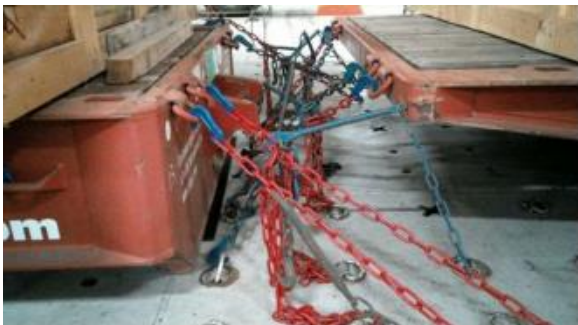
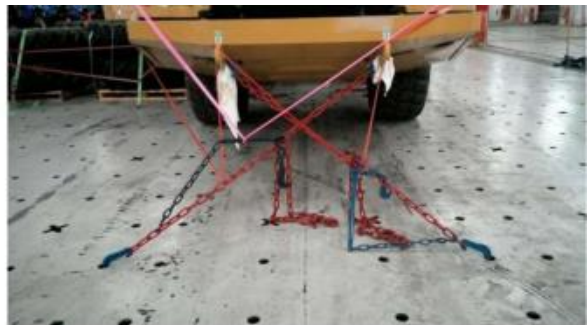
C-3 Lashing and cargo protection of H&H units.

The stevedore used clothes as damage protection on lashing points.

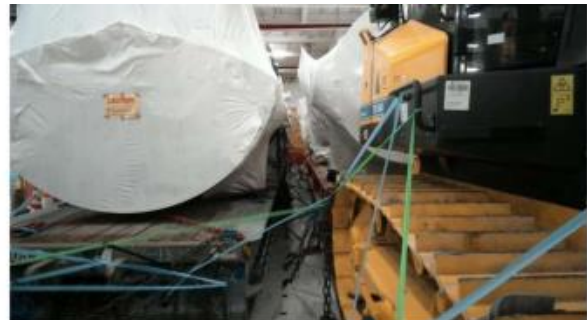
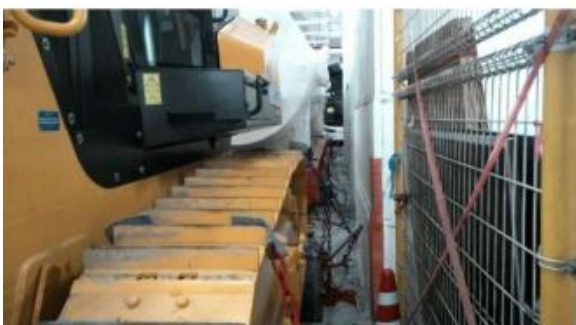
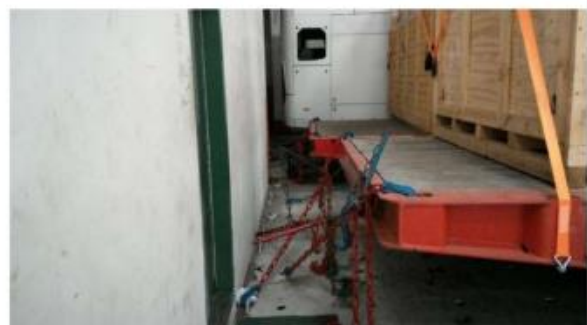
C-5 H&H cargo stowing on decks and proper stowage on rolltrailer (Mafi).

Good stowage with sufficient space for lashing.
