Carrier	PQC
Vessel	PQC VESSEL
Voyage	001 002
Operation	Post-Discharge and Pre-Load
Port	Bremerhaven
Berth	NH AK1

Audit Results

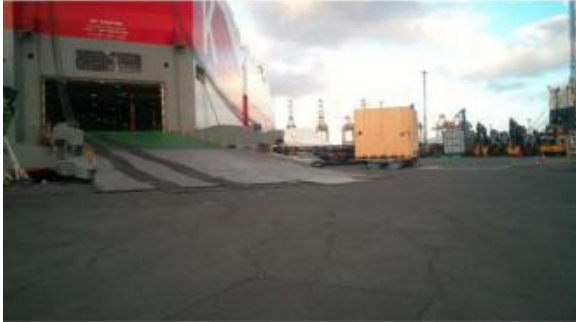
A-1 General condition Terminal.

Operations area next to the ramp was clean and without complaint.

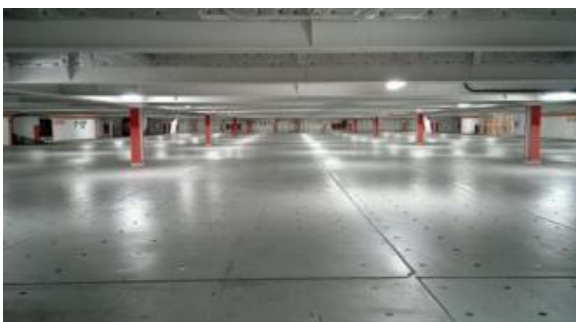
A-3 Decks clean and be in order, dry, well lit and ventilated.

All decks were cleaned up, well lit and good ventilated. Nothing to complain.

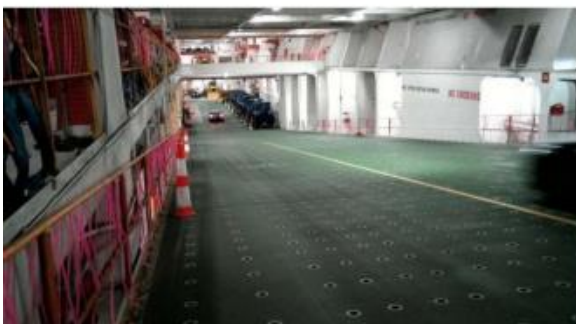
B-1 Safe speed, careful driving and 10m distance between two cars on driveways and ramps.

The drivers drive safely + carefully.

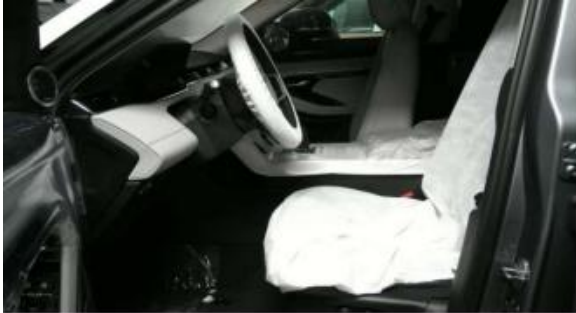
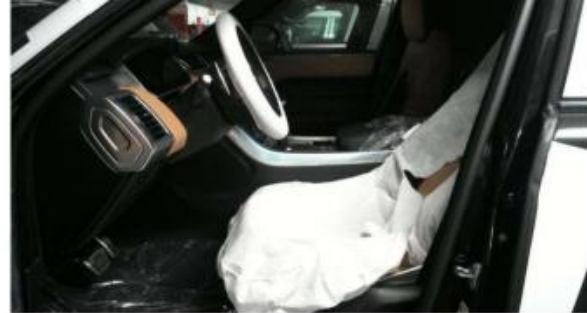
B-2 Vehicles stowed in accordance to the manufactures requirements (key, brake, seatposition, seatcover). Steering wheel in right position.

Meeting the manufactures requirements.

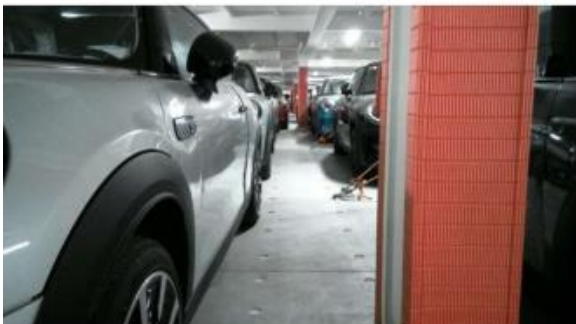
B-3 All vehicles parked correct distances with bumpers in line/sides/walkway/bulkheads/deck head and model by model. Minimum space to RoRo units ca. 1m.

The cars parked good in distance between bumpers and mirrors. Good distance also to boardwall and pillars. Loaded model by model.

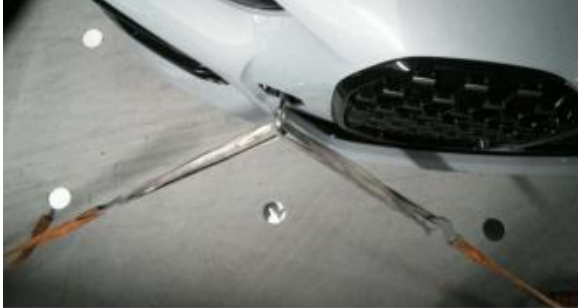
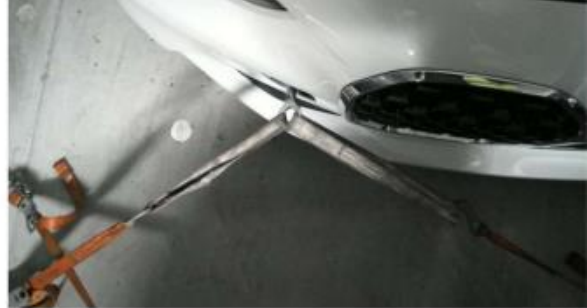
B-4 Cars spot check of loose/missing i-Bolts. Lashing with slings performed at cars with short sized i-bolts or unfavourable stowage position.

Cars with short sized i-bolt were lashed using slings as extension.

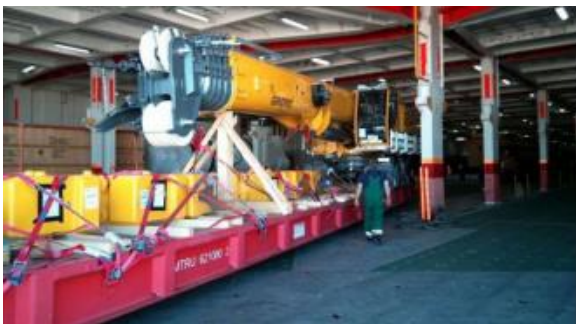
C-2 Safe handling H&H units during loading/discharging. Stevedore escort H&H onto ramp.

Good handling during loading, drive carefully on the ramps. Safety handling with tugmaster into final position. Driver acts attentive to stevedores handsigns.

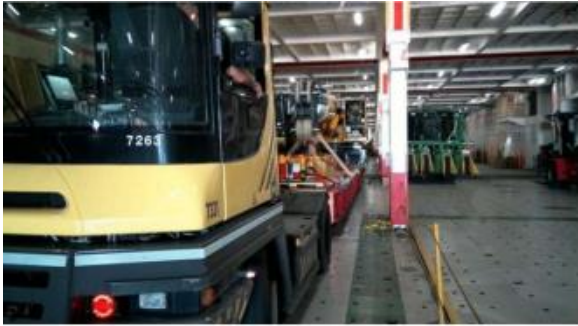
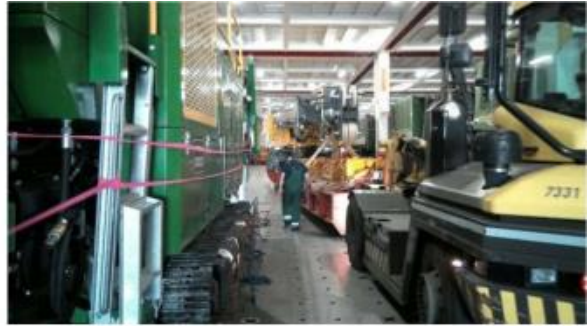
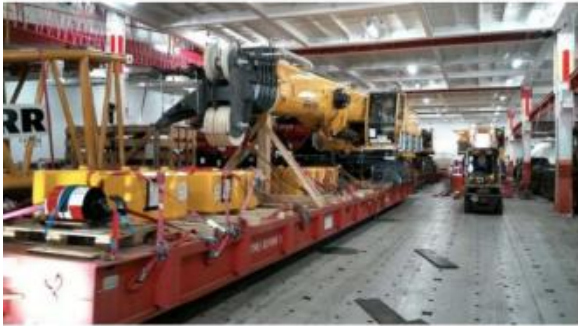
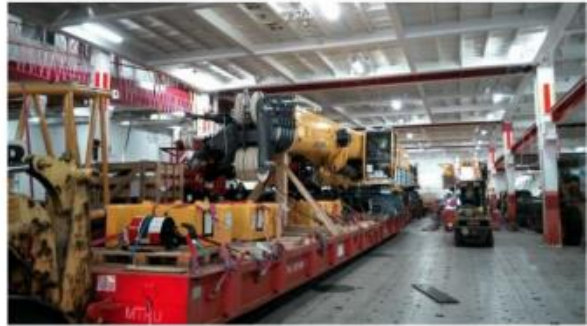
C-3 Lashing and cargo protection of H&H units.

The stevedore used clothes as damage protection on lashing points.

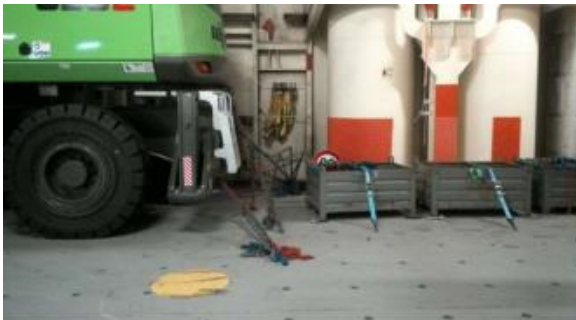
C-5 H&H cargo stowing on decks and proper stowage on rolltrailer (Mafi).

Good stowage with sufficient space for lashing.
